MATERIALS AND TECHNIQUES FOR TRADITIONAL ROMANIAN RESIDENTIAL HOUSES

Andreea Duțu*, Daniel I. Dima* and Eliza G. Bulimar*

* Technical University of Civil Engineering Bucharest
e-mails: andreea.dutu@utcb.ro, officedanielidima2012@yahoo.ro, eliza.bulimar@gmail.com

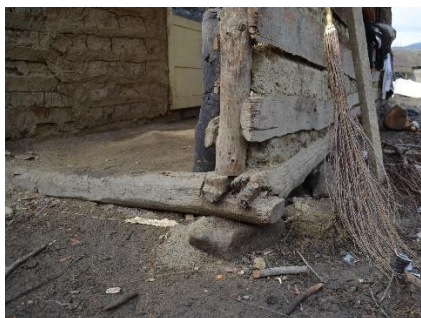
a. No foundation

Figure 14 shows the details of a Type 4 house which is a very poor executed house, due to the economic situation of the owners, it has no foundations, the walls simply sitting on the ground, and the connections between the bottom beams are also very poorly executed, lacking any nail or clamp to connect them and also having significant gaps (Figure 14 c).

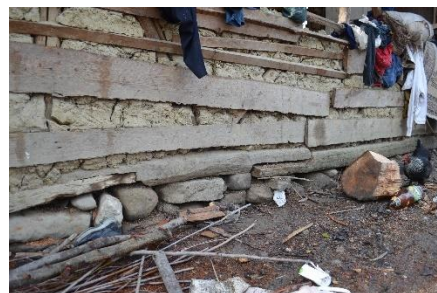
c. The bottom beam joint seems to lack joining pieces (nails or clamps)

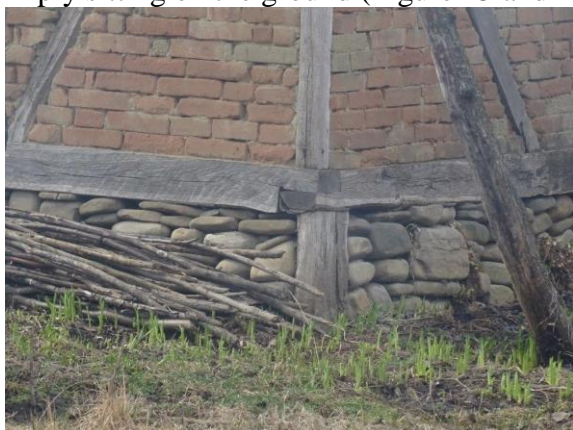
For all types presented so far, most of the foundations are made only from stone (river rocks) with or without earth mortar, but sometimes the foundation is absent, the bottom timber beam simply sitting on the ground (Figure 15 and Figure 16).

Figure 15: The foundations are made only from stone (river rocks)

The bottom timber beam is usually made of hardwood (oak tree, locust tree, etc.), and the other are generally from softwood (pinewood). The timber structure is not embedded in foundations, it is only simply supported, and this detail can allow sliding of the walls during earthquake. In this situation, the connections between the walls, if carefully executed, can allow the house to slide as a whole and not be much affected by the movement of an earthquake.

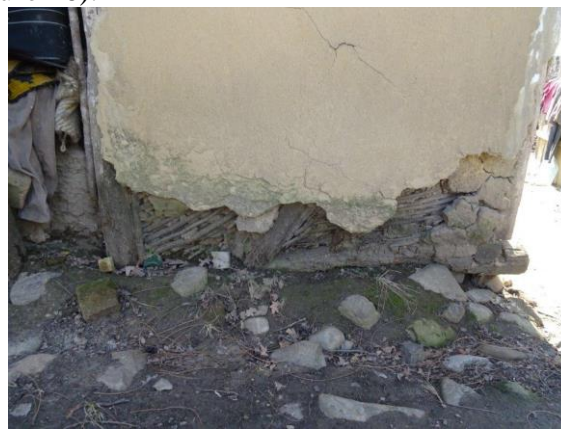
Figure 16: The bottom timber beam is simply sitting on the ground

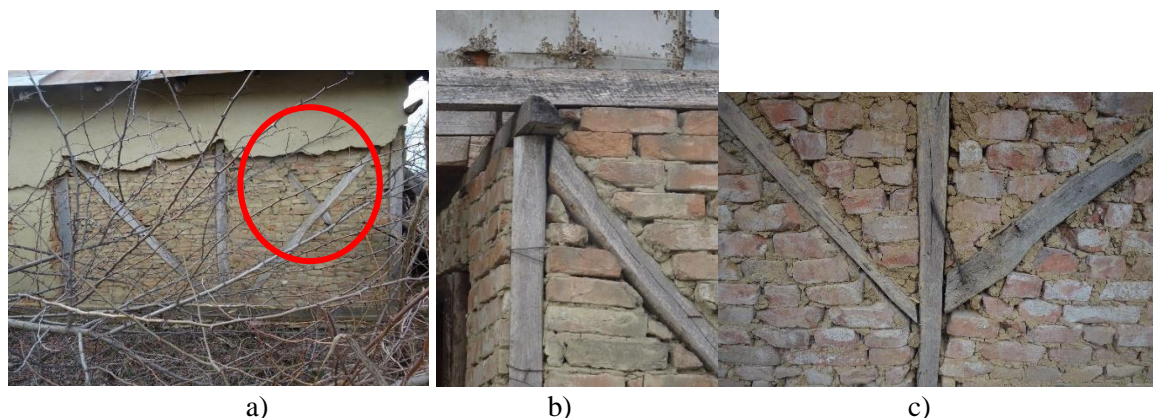
The timber frame structure is built by vertical and horizontal elements and bracings, which are positioned at the corner's and intersections of the walls, but not always in coherent distribution (Figure 17a). The joints are mostly cross-halved at the intersection of the walls (Figure 15), but they can also be joined simply with nails (Figure 17b). Occasionally, steel clamps are added to increase the resistance and stiffness of the joint (Figure 17c). The roof covering of a traditional house, in traditional solution was made by wood shingle, but now most of them are replaced because they were damaged (biological decay).

Figure 17: a) Stone foundations (river rocks); b) bracings positioned at the corner's house; c) cross-halved joints

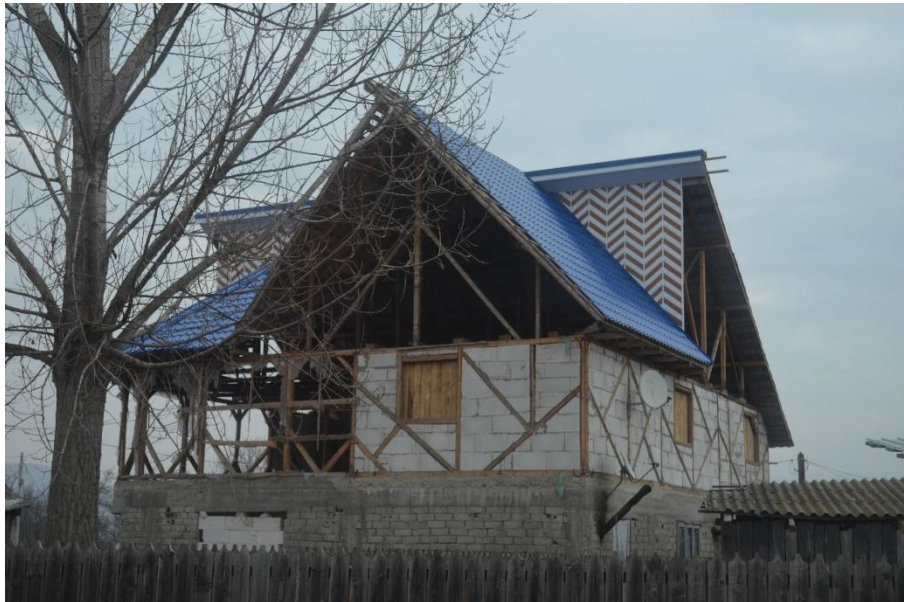
Newer type of house was found in few cases (Figure 19), and while the AAC brick has good thermal insulation properties, some details coming from traditional architecture (the timber frame and the bracings) have no meaning in the new application, due to their incoherent display.

This is a proof that the construction methods with the corresponding meanings are being lost, and this phenomenon can be dangerous for the future earthquake.

Figure 19: Building with timber skeleton and AAC (autoclaved aerated concrete) masonry infill (Type 5), from Viperesti, Buzau county
