MATERIALS AND TECHNIQUES FOR TRADITIONAL ROMANIAN RESIDENTIAL HOUSES

Andreea Duțu*, Daniel I. Dima* and Eliza G. Bulimar*

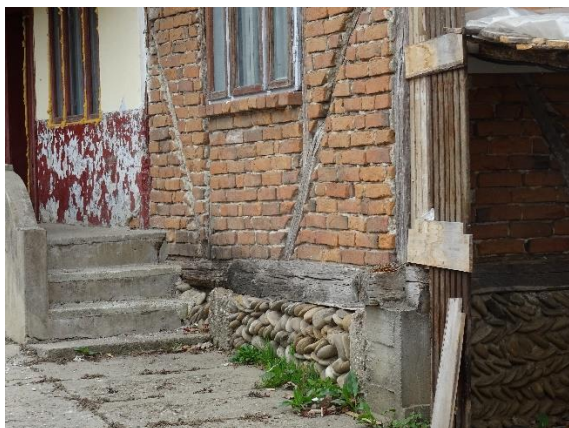
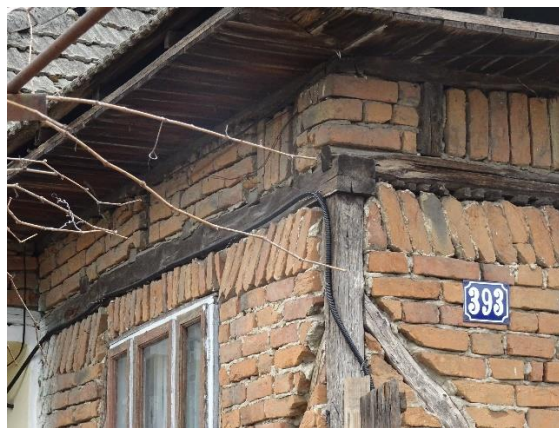
Figure 8: Details of traditional house with timber skeleton and brick masonry infill (Type 1) from Teiș village, Dâmbovița county

a. The foundations are made only from stone (river rocks)

b. The diagonals are stopped below the upper connection between beam and column, and the last row of bricks is laid in an inclined position

The Type 1 house has some details such as the diagonals being stopped lower than the connection between the beam and the post and also, the last layer of bricks, beneath the beam, is laid in an inclined position. In some situations, over the upper beam of the wall, few layers of bricks exist and another beam, supporting the roof (Figure 8 a and b). If we compare with the original type (Figure 5), we can see these details are not seen, and also the original foundation would be with wooden piles, driven in the soil.

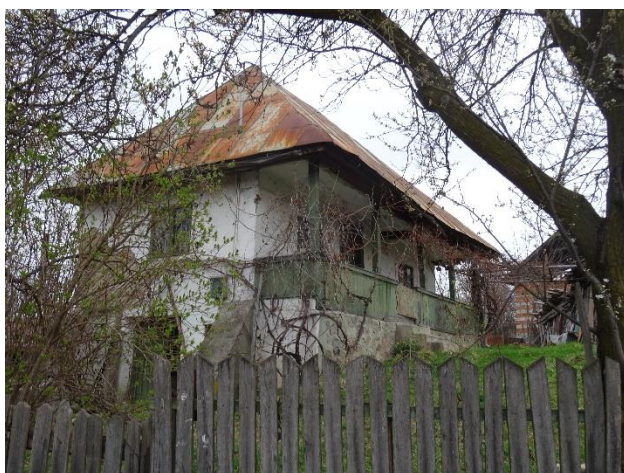
For Type 2 house (Figure 9) it can be observed the presence of the storage room at the ground floor, beneath the living rooms of the house. The internal structure of the wall could not be very well identified, since it is embedded in mud, but a timber structure made of posts should be the main structure, on which the 45° wood strips (Figure 10) are attached with nails, and infilled with mud. This structural type is very similar with the next one presented, Type 4, where the strips are horizontal instead of inclined at 45°.

Figure 9: Traditional house with timber skeleton and strips applied at 45° and clay plaster (Type 2) from Mustățești, Argeș county;

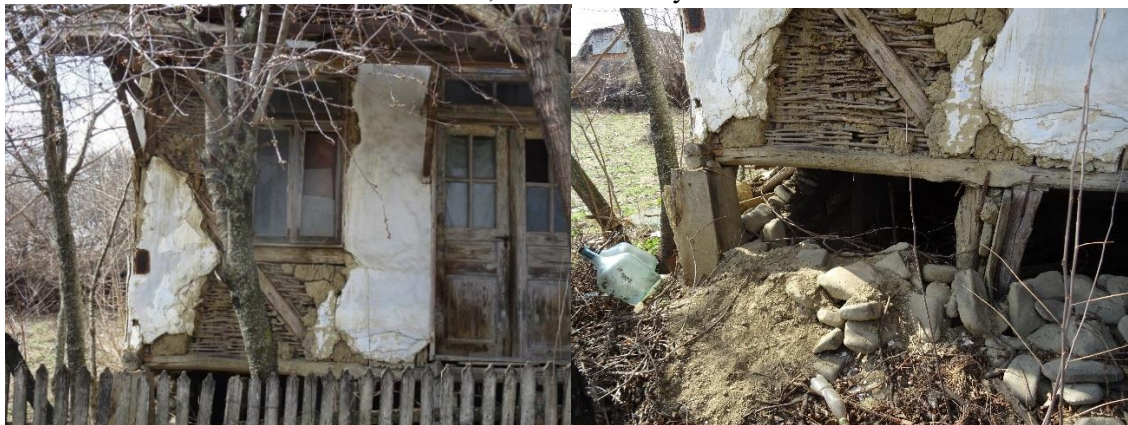
Figure 12: Details of traditional house with timber skeleton and wattle and daub (Type 3) over 100 years, from Băbeni, Vrancea county

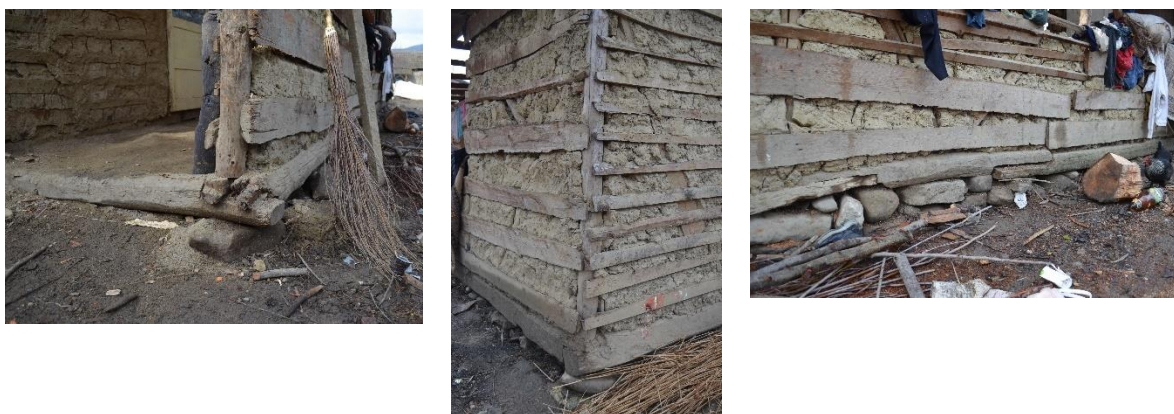
Figure 14: Details of a building with timber and earth with straw infill structure (Type 4), from Viperești, Buzău county

a. No foundation

b. Corner detail

c. The bottom beam joint seems to lack joining pieces (nails or clamps)

Figure 14 shows the details of a Type 4 house which is a very poor executed house, due to the economic situation of the owners, it has no foundations, the walls simply sitting on the ground, and the connections between the bottom beams are also very poorly executed, lacking any nail or clamp to connect them and also having significant gaps (Figure 14 c).

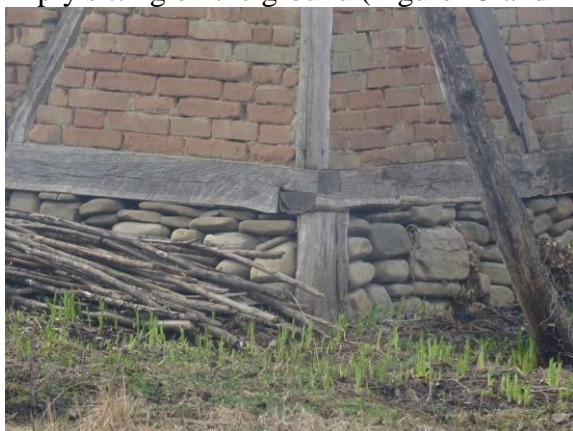
For all types presented so far, most of the foundations are made only from stone (river rocks) with or without earth mortar, but sometimes the foundation is absent, the bottom timber beam simply sitting on the ground (Figure 15 and Figure 16).

Figure 15: The foundations are made only from stone (river rocks)

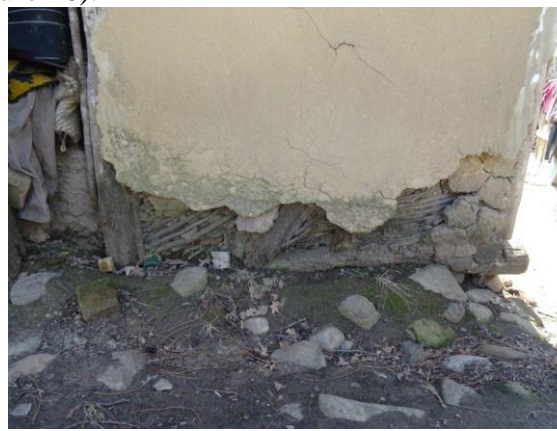
Figure 16: The bottom timber beam is simply sitting on the ground

The bottom timber beam is usually made of hardwood (oak tree, locust tree, etc.), and the other are generally from softwood (pinewood). The timber structure is not embedded in foundations, it is only simply supported, and this detail can allow sliding of the walls during earthquake. In this situation, the connections between the walls, if carefully executed, can allow the house to slide as a whole and not be much affected by the movement of an earthquake.

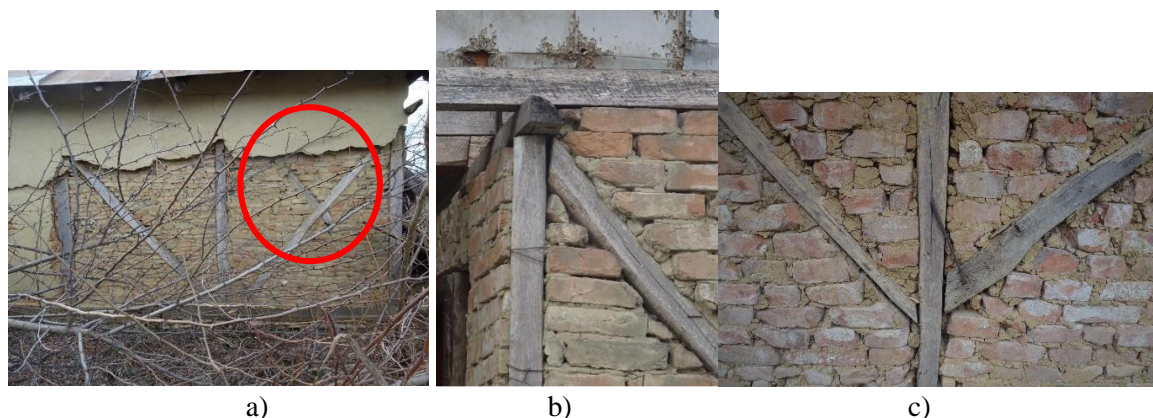
The timber frame structure is built by vertical and horizontal elements and bracings, which are positioned at the corner's and intersections of the walls, but not always in coherent distribution (Figure 17a). The joints are mostly cross-halved at the intersection of the walls (Figure 15), but they can also be joined simply with nails (Figure 17b). Occasionally, steel clamps are added to increase the resistance and stiffness of the joint (Figure 17c). The roof covering of a traditional house, in traditional solution was made by wood shingle, but now most of them are replaced because they were damaged (biological decay).

Figure 17: a) Stone foundations (river rocks); b) bracings positioned at the corner's house; c) cross-halved joints

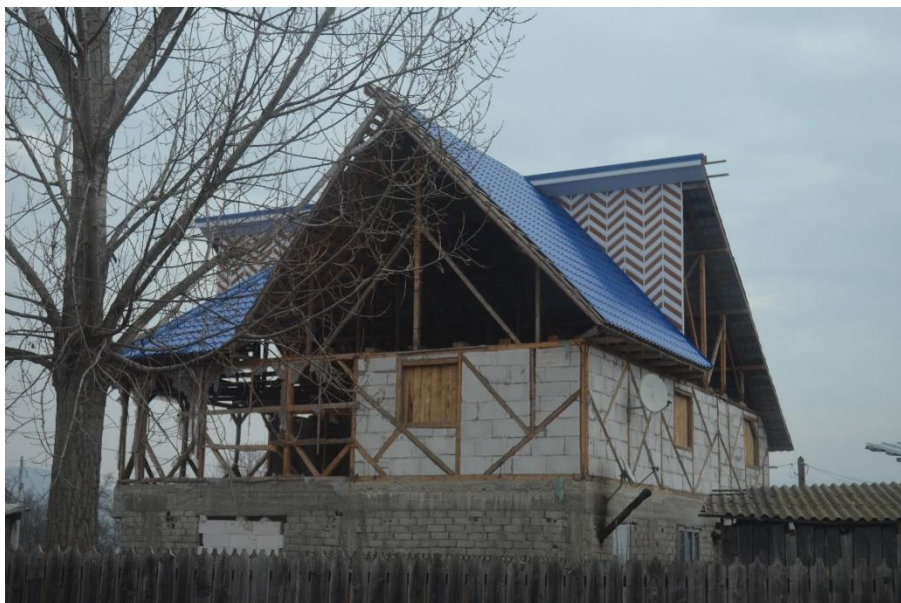
Newer type of house was found in few cases (Figure 19), and while the AAC brick has good thermal insulation properties, some details coming from traditional architecture (the timber frame and the bracings) have no meaning in the new application, due to their incoherent display.

This is a proof that the construction methods with the corresponding meanings are being lost, and this phenomenon can be dangerous for the future earthquake.

Figure 19: Building with timber skeleton and AAC (autoclaved aerated concrete) masonry infill (Type 5), from Viperesti, Buzau county
