MATERIALS AND TECHNIQUES FOR TRADITIONAL ROMANIAN RESIDENTIAL HOUSES

Andreea Duțu*, Daniel I. Dima* and Eliza G. Bulimar*

* Technical University of Civil Engineering Bucharest
e-mails: andreea.dutu@utcb.ro, officedanielidima2012@yahoo.ro, eliza.bulimar@gmail.com

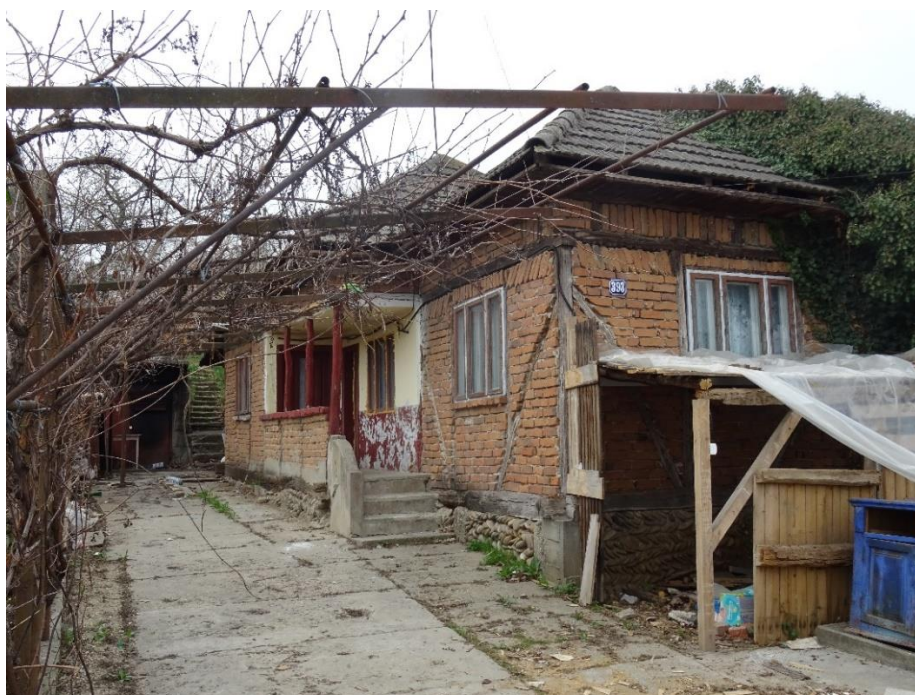
Figure 7: Traditional house with timber skeleton and brick masonry infill (Type 1) from Teiș village, Dâmbovița county

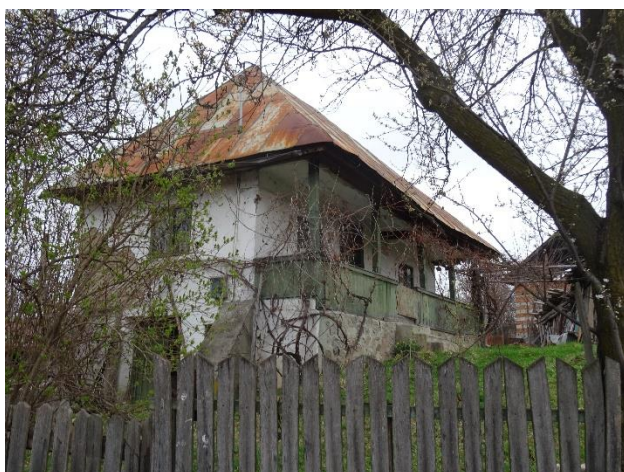
For Type 2 house (Figure 9) it can be observed the presence of the storage room at the ground floor, beneath the living rooms of the house. The internal structure of the wall could not be very well identified, since it is embedded in mud, but a timber structure made of posts should be the main structure, on which the 45° wood strips (Figure 10) are attached with nails, and infilled with mud. This structural type is very similar with the next one presented, Type 4, where the strips are horizontal instead of inclined at 45°.

Figure 9: Traditional house with timber skeleton and strips applied at 45° and clay plaster (Type 2) from Mustățești, Argeș county;

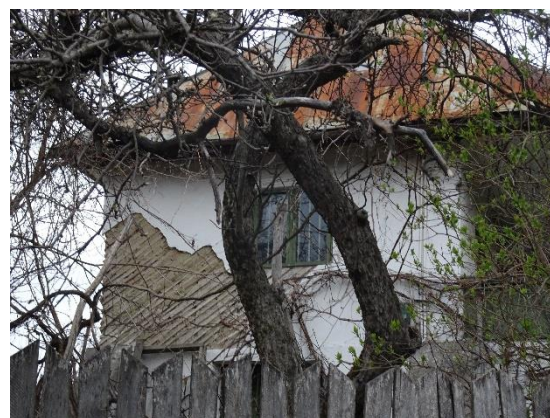
Figure 10: Detail of traditional house with timber skeleton and strips applied at 45° and clay plaster (Type 2) from Mustățești, Argeș county;

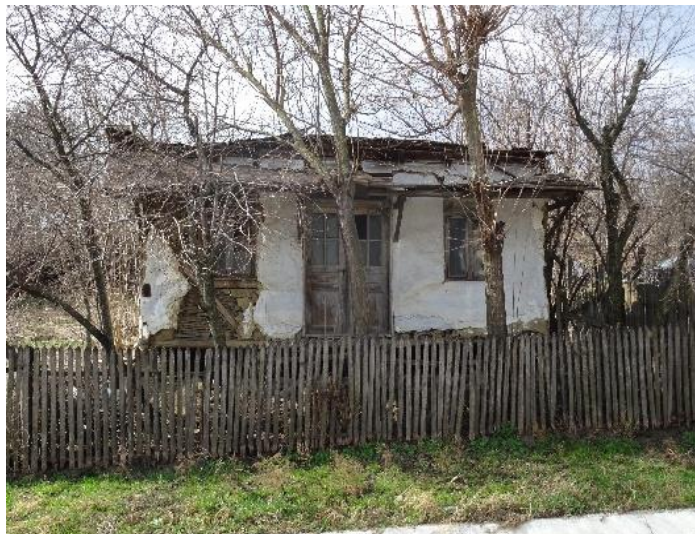
Type 3 house (Figure 11) is made with similar structure type as Type 2, but instead of strips applied on the exterior of the main timber structure (posts, smaller size posts and beams), between the posts and smaller posts, hazelnut branches are braided and they are covered with mud mortar, which by drying it forms together the wattle and daub system.

Figure 11: Traditional house with timber skeleton and wattle and daub (Type 3 – ”grădele”) from Băbeni, Vrancea county

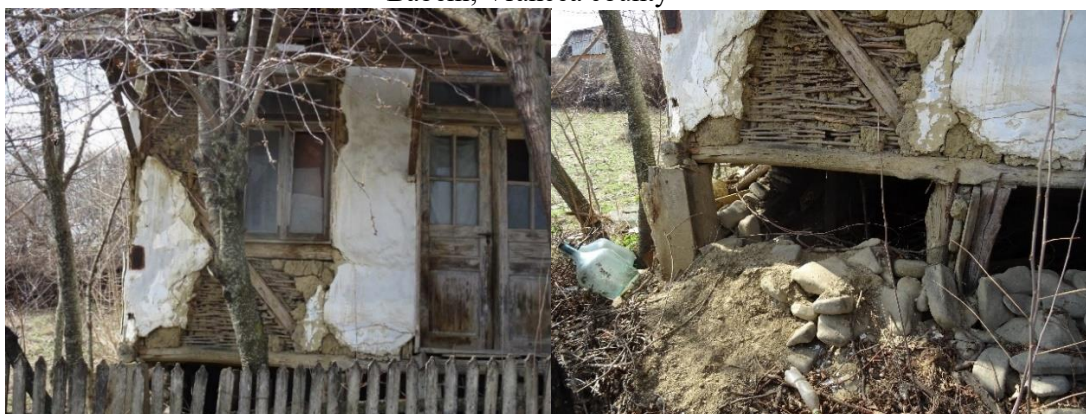
Figure 12: Details of traditional house with timber skeleton and wattle and daub (Type 3) over 100 years, from Băbeni, Vrancea county

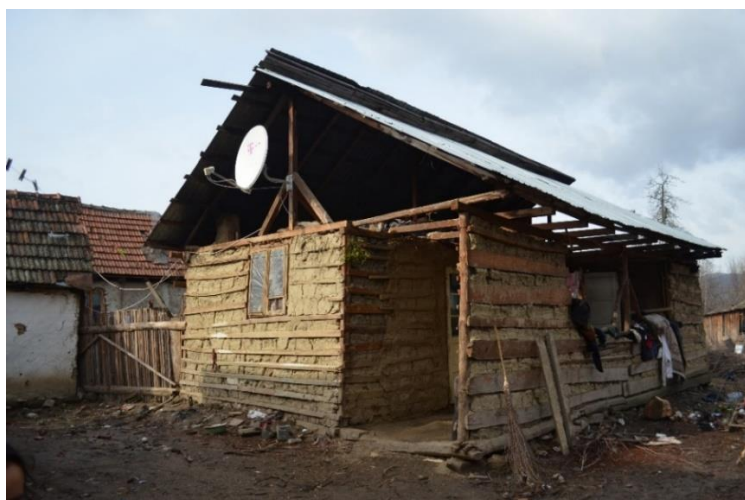
Figure 13: Building with timber and earth with straw infill structure (Type 4), from Viperești, Buzău county

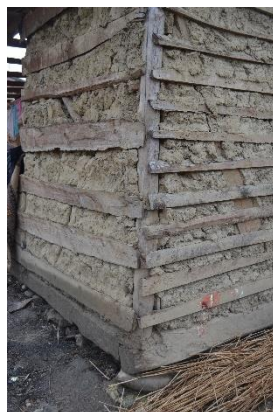
b. Corner detail

Figure 14: Details of a building with timber and earth with straw infill structure (Type 4), from Viperești, Buzău county

Figure 14 shows the details of a Type 4 house which is a very poor executed house, due to the economic situation of the owners, it has no foundations, the walls simply sitting on the ground, and the connections between the bottom beams are also very poorly executed, lacking any nail or clamp to connect them and also having significant gaps (Figure 14 c).

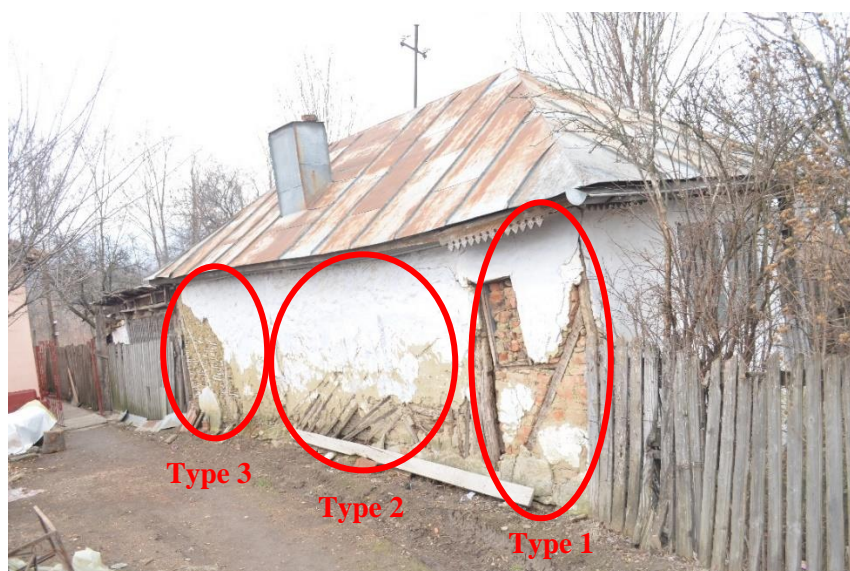
Most of them are abandoned and they aren't maintained properly, and also, the geotechnical phenomena (settling, landslides, etc.) mainly caused cracks and walls overturning. Most of the houses are one story high, but occasionally, they can be with upper story (Figure 9), having the architecture as a house with the living space at the upper floor, while at the ground floor the owners have the storage rooms. Due to this reason, the ground floor walls are made of stone or brick masonry, while the upper floor can be made of one of the 5 types described in this paper. In rare situations, one can find also a combination of several types (Figure 18), and this may be explained as reparations after earthquakes (maybe different earthquakes), as the houses seems very old and might have exhibited also both 1940 and 1977 seismic events in Romania.

Figure 18: Traditional house with Type 1+2+3, from Viperesti, Buzău county
