MATERIALS AND TECHNIQUES FOR TRADITIONAL ROMANIAN RESIDENTIAL HOUSES

Andreea Duțu*, Daniel I. Dima* and Eliza G. Bulimar*

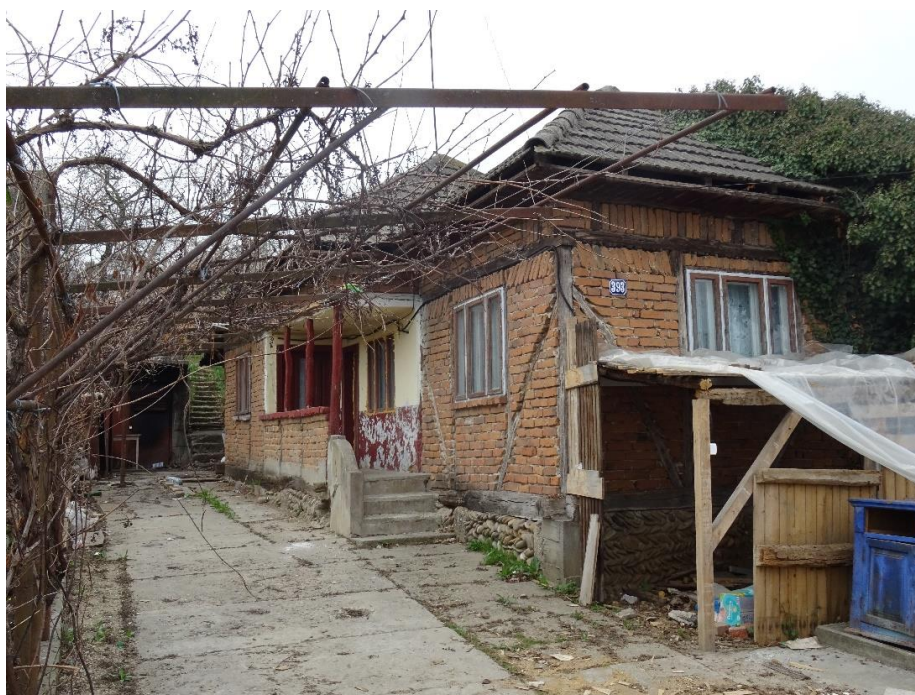
Figure 7: Traditional house with timber skeleton and brick masonry infill (Type 1) from Teiș village, Dâmbovița county

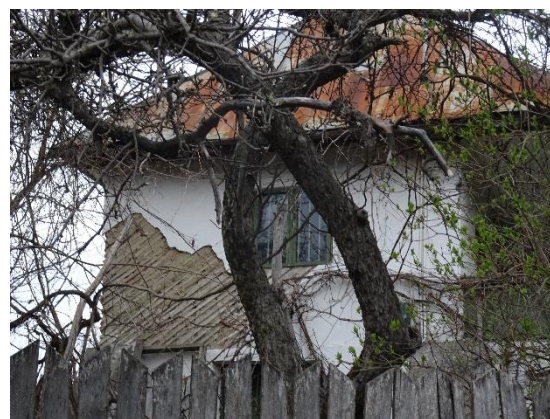
For Type 2 house (Figure 9) it can be observed the presence of the storage room at the ground floor, beneath the living rooms of the house. The internal structure of the wall could not be very well identified, since it is embedded in mud, but a timber structure made of posts should be the main structure, on which the 45° wood strips (Figure 10) are attached with nails, and infilled with mud. This structural type is very similar with the next one presented, Type 4, where the strips are horizontal instead of inclined at 45°.

Figure 10: Detail of traditional house with timber skeleton and strips applied at 45° and clay plaster (Type 2) from Mustățești, Argeș county;

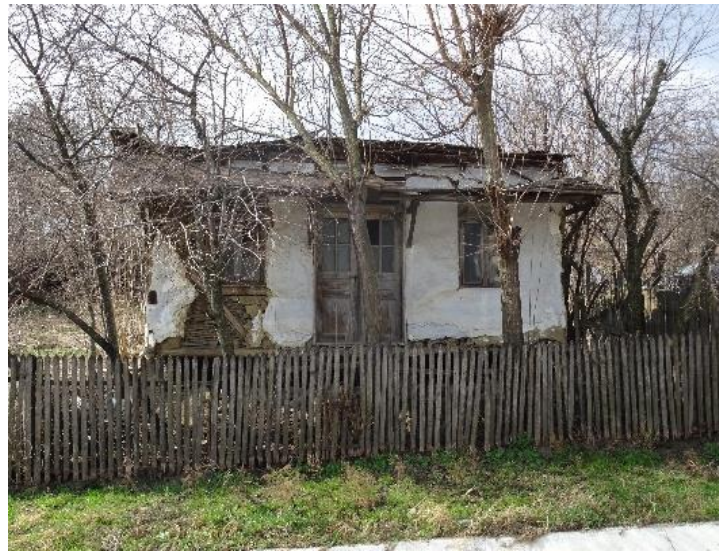
Type 3 house (Figure 11) is made with similar structure type as Type 2, but instead of strips applied on the exterior of the main timber structure (posts, smaller size posts and beams),

between the posts and smaller posts, hazelnut branches are braided and they are covered with mud mortar, which by drying it forms together the wattle and daub system.

Figure 11: Traditional house with timber skeleton and wattle and daub (Type 3 – ”grădele”) from Băbeni, Vrancea county

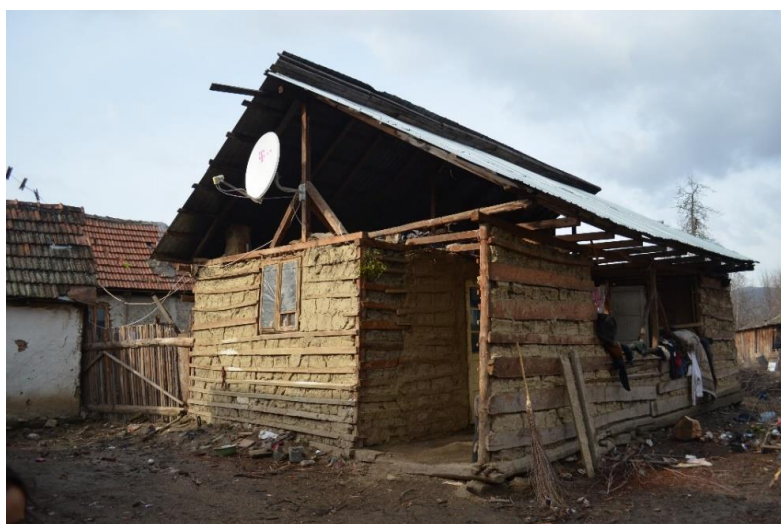
Figure 13: Building with timber and earth with straw infill structure (Type 4), from Viperești, Buzău county

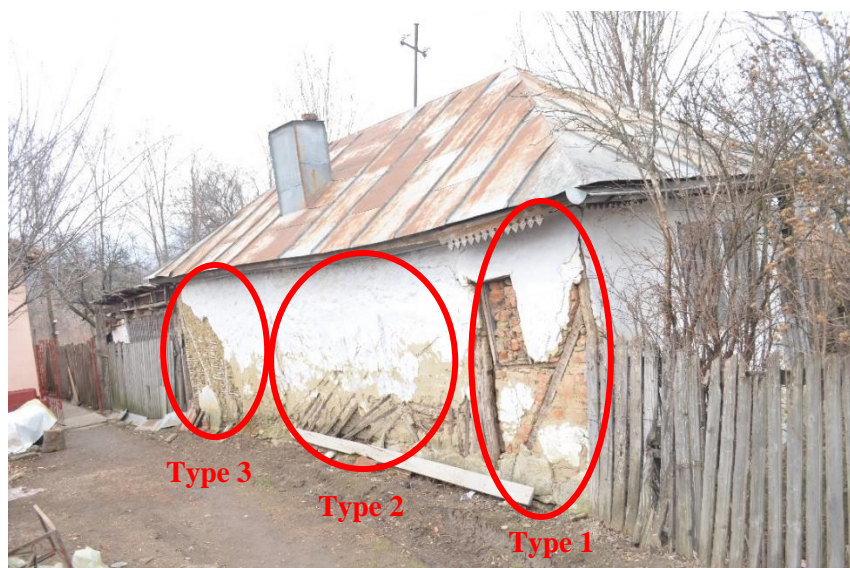
Most of them are abandoned and they aren't maintained properly, and also, the geotechnical phenomena (settling, landslides, etc.) mainly caused cracks and walls overturning. Most of the houses are one story high, but occasionally, they can be with upper story (Figure 9), having the architecture as a house with the living space at the upper floor, while at the ground floor the owners have the storage rooms. Due to this reason, the ground floor walls are made of stone or brick masonry, while the upper floor can be made of one of the 5 types described in this paper. In rare situations, one can find also a combination of several types (Figure 18), and this may be explained as reparations after earthquakes (maybe different earthquakes), as the houses seems very old and might have exhibited also both 1940 and 1977 seismic events in Romania.

Figure 18: Traditional house with Type 1+2+3, from Viperesti, Buzău county
